MEMORANDUM

RE: Intersection @ Park Ave and Route 2's Frontage Roads

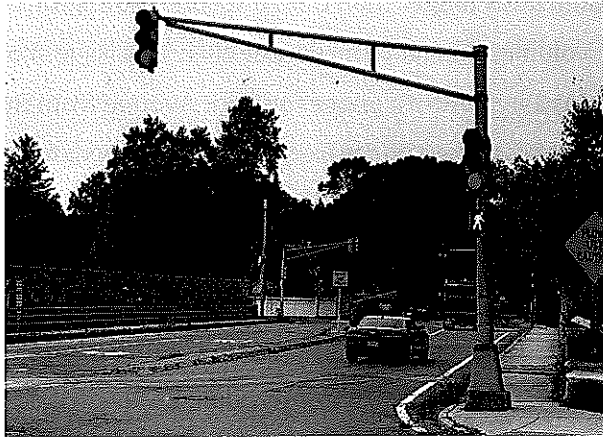
they had a green light, because of a missing visor on a Park Avenue signal, as seen in the photo to the right. Furthermore, outdated "doghouse" style left turn signals currently exist at this location. MassDOT

- Perform maintenance on this signal, to check that it is up to MassDOT standards.
- Install Flashing Yellow Arrow left turn signals to replace older style 5-section signals.
  - Program a pedestrian protect phase, so that if a pedestrian clicks the crosswalk button, left turns are converted to protected only so that pedestrians can cross in a safer manner. (See image on right)
